# Structural Integrity Assessment of a Sour Service Low Pressure Production Trap Using Fitness-for-Service Methodology

Mohammed S. Al-Robai<sup>1</sup>; Abdulrahman A. Alkhateeb<sup>2</sup>

Equipment Consulting Services Department, Saudi Aramco  
Dhahran 31311, Saudi Arabia

Publication Date: 2025/08/01

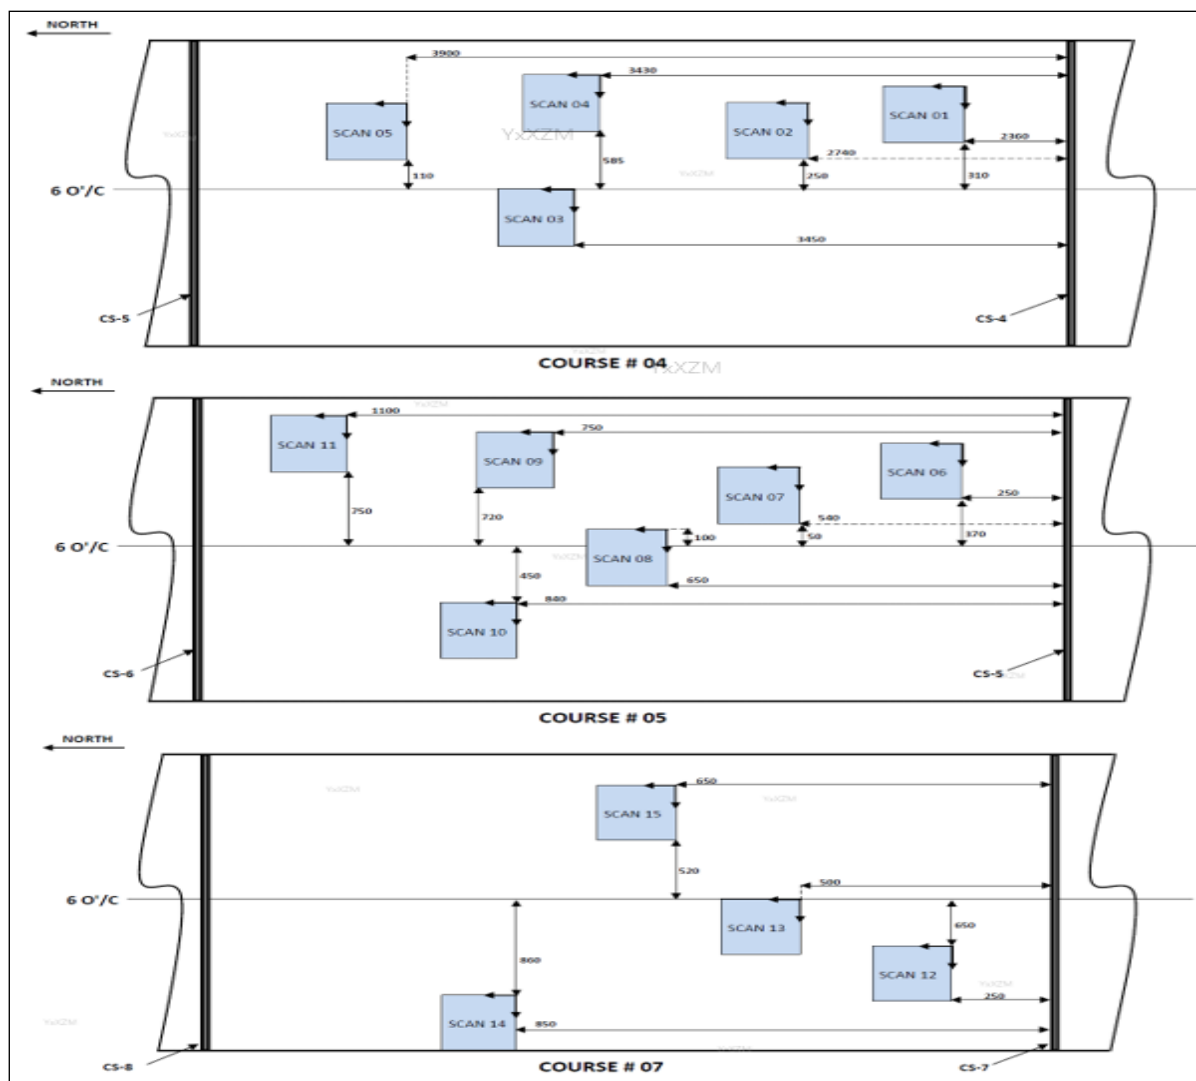
Fig 1. Course 4, 5, and 7 Including Scans Location.

The inspection of the LPPT was conducted using an automated ultrasonic testing (AUT) system (Equipment ID: SCNR-1116) to evaluate subsurface defects in critical shell courses (Courses #04, #05, and #07). Key parameters included:

- Material: CS A-516 Gr. 65
- Nominal Wall Thickness: 18.0 mm
- Scans: 300 mm × 300 mm grids across critical zones (Courses #04, #05, #07) as shown in Fig. 1.

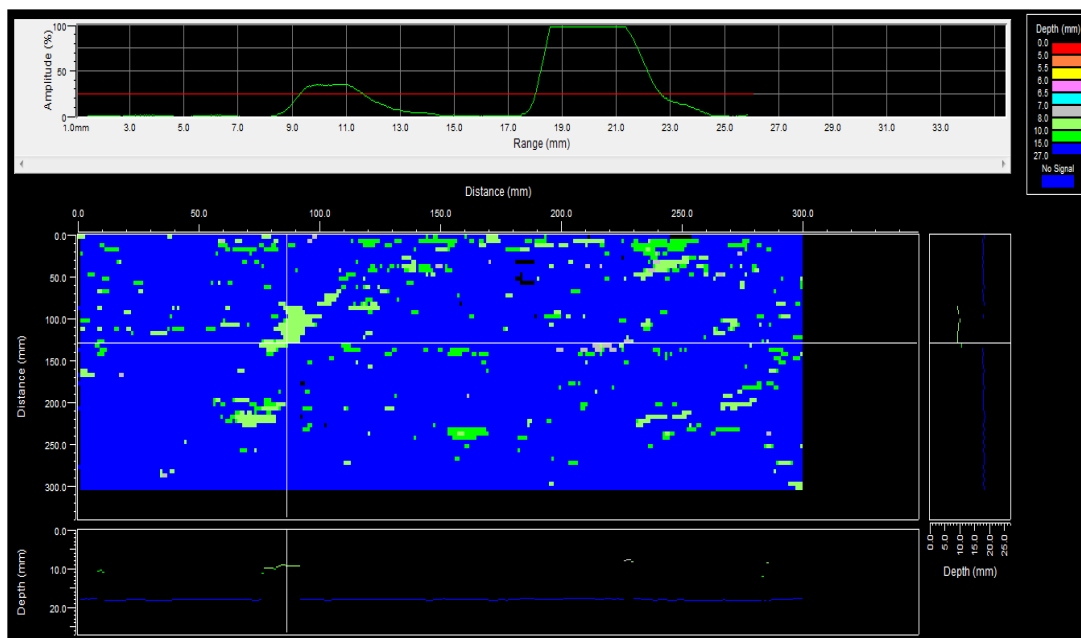
Fig 2. Course 4, 5, and 7 Including Scans Location.

Key observations from the inspection results revealed that the largest step-wise crack had a height of 2.2 mm, located in Course #07, Scan 13, and notably, no growth was detected in these cracks since the 2022 inspections. Additionally, the inspection identified hydrogen-induced cracking (HIC) and inclusions, with the deepest defect measuring 14.8 mm in Course #07, Scan 15, and the shallowest defect measuring 7.3 mm in Course #07, Scan 13. Figures 2-6 and Table 1 show the advance ultrasonic inspection readings across the critical zones.

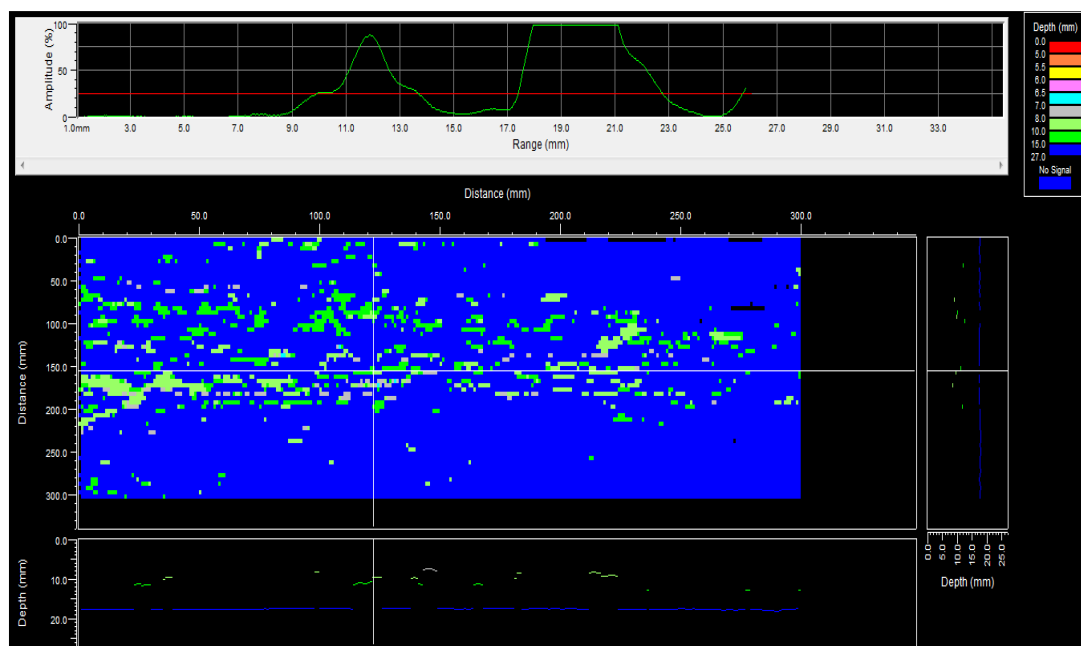
Fig 3. Shell Course #4 Scan 03

Scan Location	Defect Type	Max Crack Height (mm)	Depth Range (mm)	Crack Growth vs. 2022
Course 04, Scan 02	Step-wise cracks	2.2	12.8–14.8	No growth
Course 04, Scan 03	Step-wise cracks	1.9	9.2–14.0	No growth
Course 05, Scan 10	HIC/Inclusions	N/A	7.7–14.4	N/A
Course 07, Scan 13	Step-wise cracks	2.2	7.3–14.7	No growth
All Scans	HIC/ Inclusions	N/A	7.3–14.8 (ave. 11.2)	N/A

To ensure sustained safety, biennial AUT inspections should prioritize monitoring Courses #04 and #07, where defects were most severe. Proactive measures, such as applying corrosion-resistant coatings (e.g., epoxy) and maintaining strict H<sub>2</sub>S partial pressure control, are recommended to further mitigate risks. A reassessment every five years or following operational changes (e.g., pressure adjustments) will ensure ongoing compliance with integrity standards.

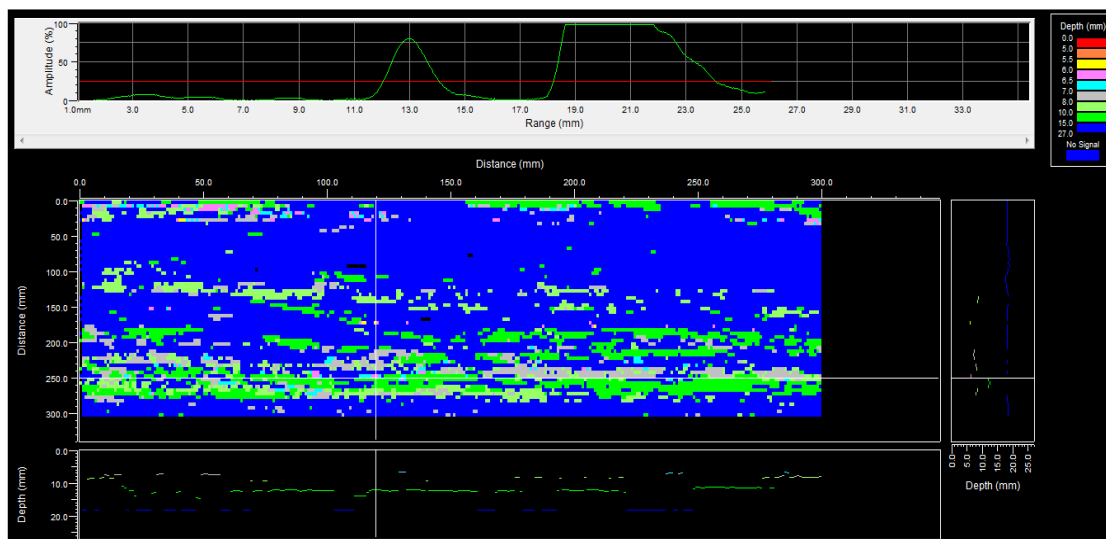
Fig 5. Shell Course #7 Scan 13

The Fitness-for-Service assessment outcomes revealed that the crack heights and depths were within acceptable limits, with crack maximum heights of 2.2 mm which satisfying through-thickness extent of the damage less than 4.9 mm, and subsurface requirement (depths of 12.8 mm), thereby satisfying the API-579 screening criteria for Level 1 compliance and therefore no need to conduct Level 2 assessment.
