Causes, Impacts, and Remedial Measures for Rising Damp in Tropical Residential Buildings: A Study of Southern Adamawa State, Nigeria

Publication Date: 2025/06/16

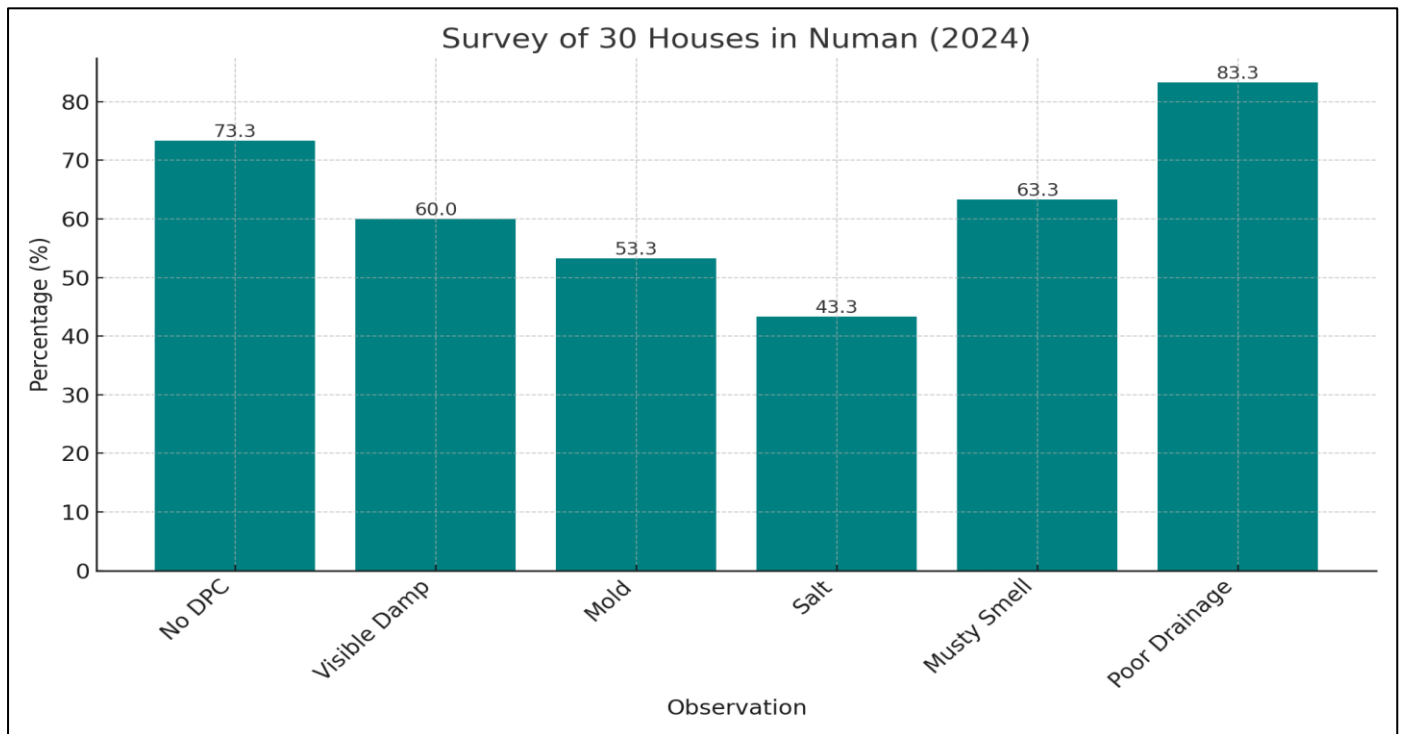
Fig 2 Survey of 30 Houses in Numan (2024)

Observation Category	Number of Houses	Percentage (%)
No Damp-Proof Course (DPC)	22	73.3%
Visible Rising Damp (1m or higher)	18	60.0%
Indoor Mould or Mildew	16	53.3%
Salt Deposits on Walls	13	43.3%
Musty Smell Indoors	19	63.3%
Poor Drainage Around Building	25	83.3%

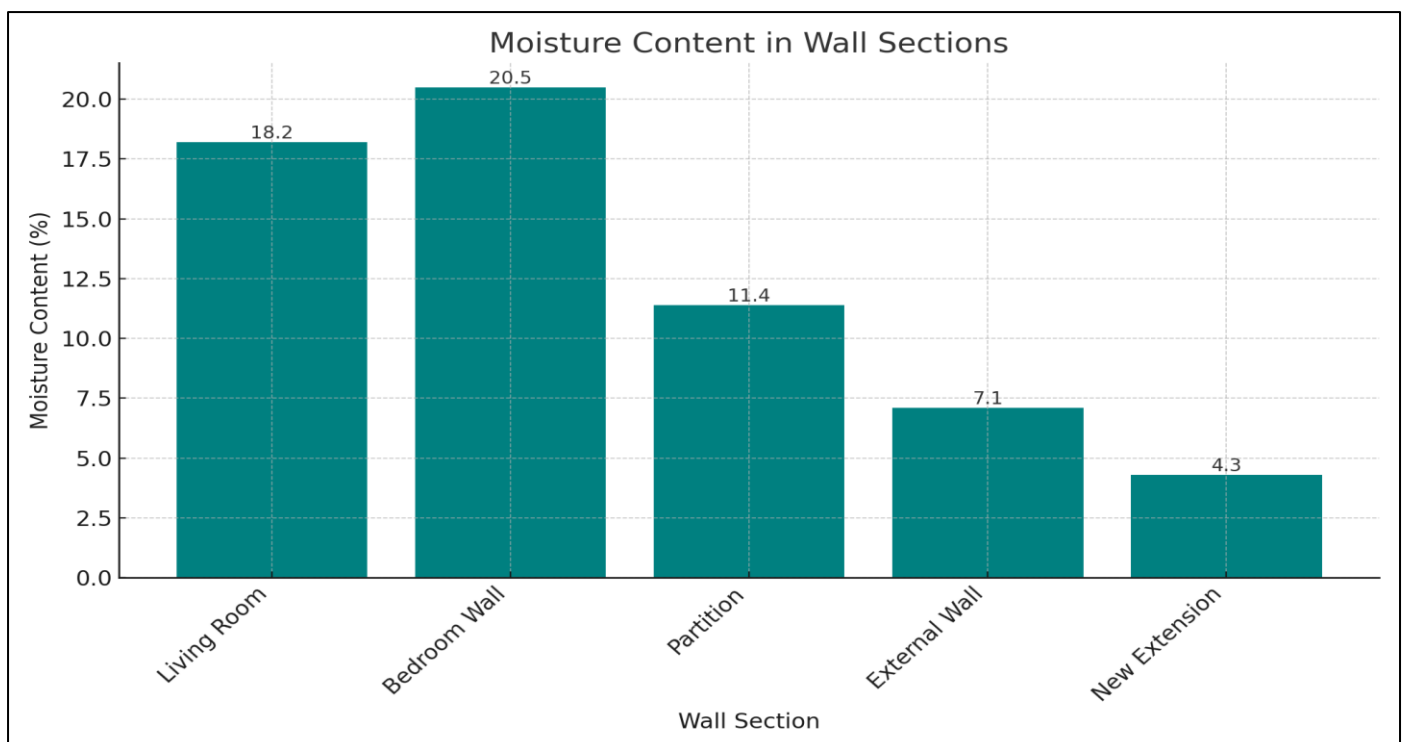
Fig 3 Moisture Content in Wall Sections

Wall Section	Moisture Content (%)	Condition
Living Room (damp)	18.2%	High moisture
Bedroom Wall (damp)	20.5%	Very damp
Interior Partition	11.4%	Moderately damp
Sunny External Wall	7.1%	Acceptable
New Extension (with DPC)	4.3%	Dry

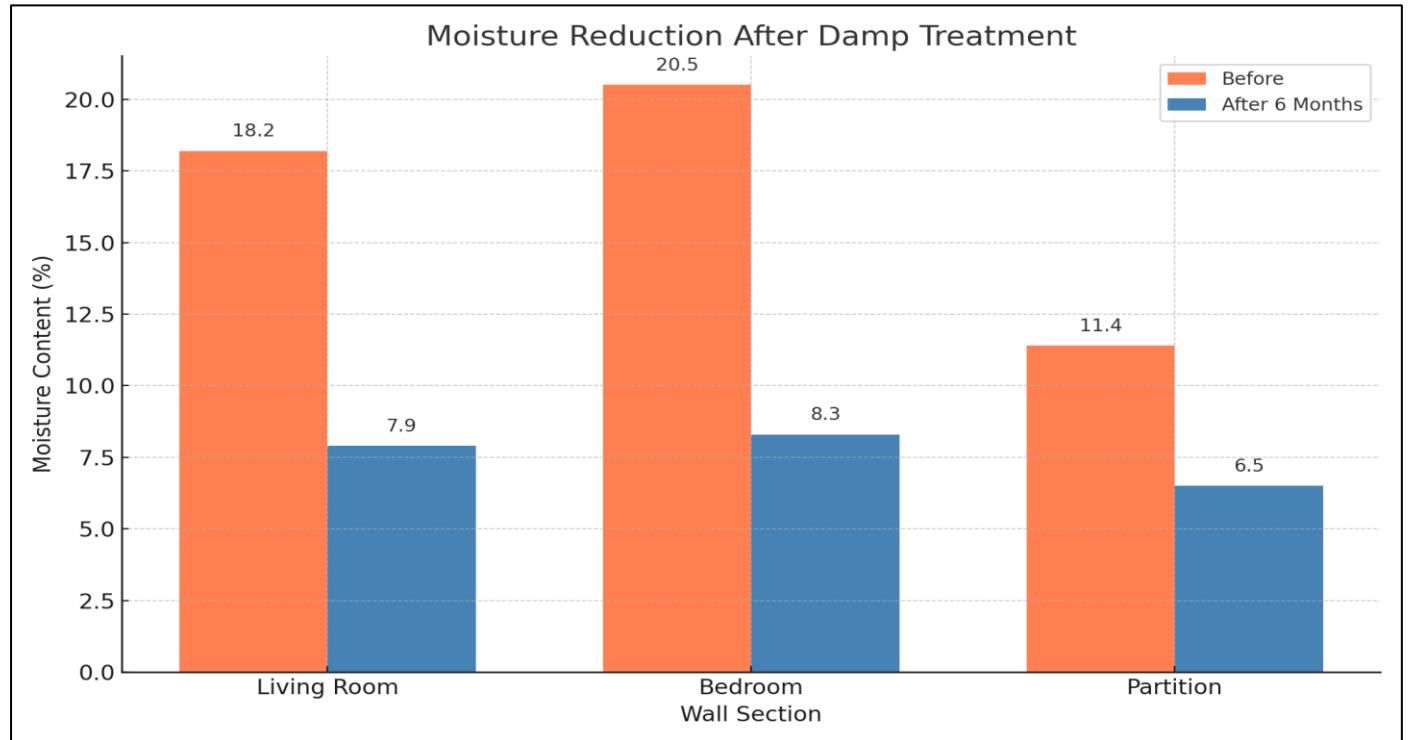
Fig 4 Moisture Reduction after Damp Treatment

Wall Treated	Before (%)	After 6 Months (%)	Improvement (%)
Living Room Wall	18.2%	7.9%	56.6%
Bedroom Wall	20.5%	8.3%	59.5%
Partition Wall	11.4%	6.5%	43.0%

To address the structural and moisture-related issues identified, a series of targeted remedial measures was implemented. A silicone-based chemical damp-proof course

(DPC) was injected into the ground-level walls to inhibit further capillary rise of moisture. This intervention is an effective horizontal barrier within the masonry, mitigating internal dampness and protecting against long-term water ingress.
