A Novel Approach to Strengthening Endodontically Treated Teeth: Horizontal Fiber Post Technique – Case Report

^{1,2,3,4,5} Head of department & Professor, Department of Conservative Dentistry and Endodontics, Jaipur Dental College, Jaipur, India

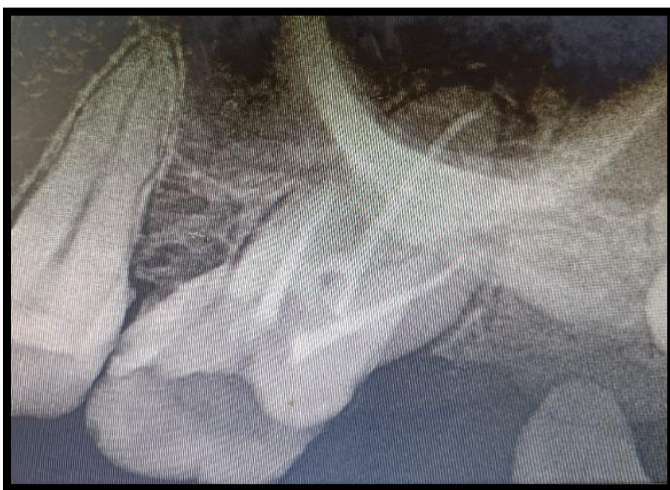
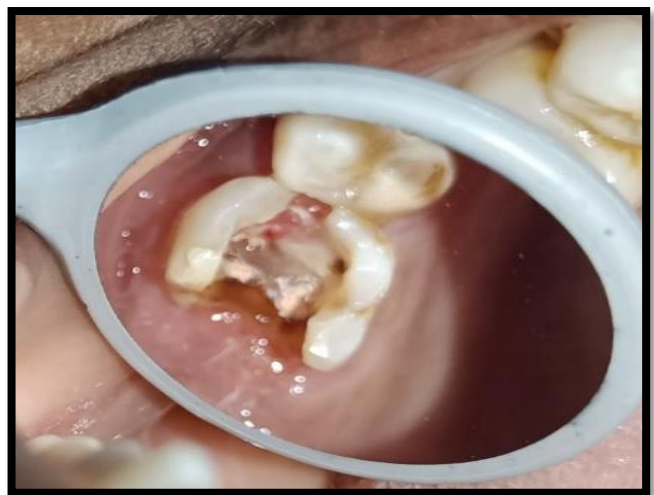
Fig 1 Post Obturation (Radiograph And Intraoral)

using 3% sodium hypochlorite. The canals were then reinstrumented and obturated with the single-cone technique using a resin-based sealer (Fig. 1).

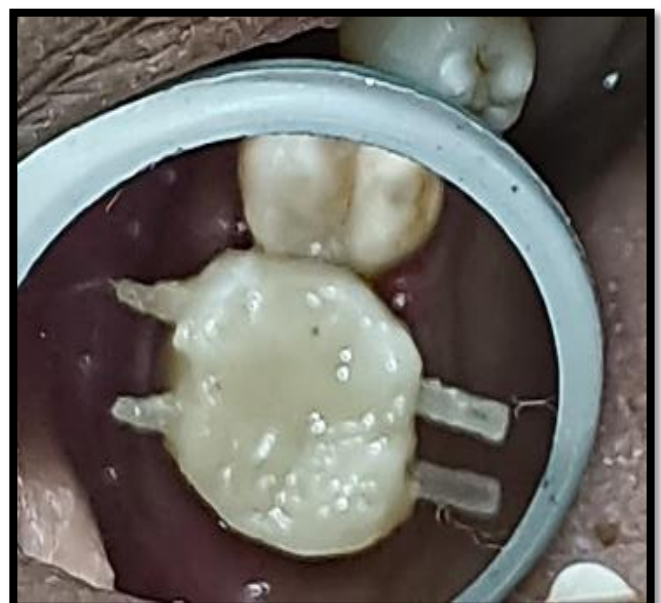
Fig 3 Luting of the Fiber Post and Build Up

For coronal reinforcement, two horizontal slots were prepared across the buccal and lingual walls with a tapered fissure bur (Fig. 2). The pulp chamber was etched, bonded, and filled with flow able composite around the orifices and pulpal floor. Two prefabricated fiber posts were inserted bucco–lingual and luted with dual-cure composite resin (Fig. 3). Any excess post material extending beyond the buccal and lingual surfaces was carefully trimmed (Fig. 4). The restoration was then polished and finished, and its integrity was confirmed with a postoperative radiograph (Fig. 5).

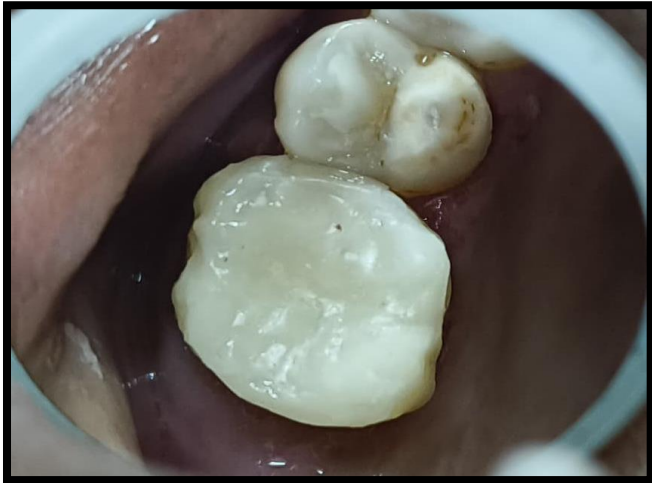
Fig 4 Resection of the Protruding Portion of Post.
